DEVELOPMENT OF ADVANCED LIGHTWEIGHT SYSTEMS CONTAINMENT FINAL REPORT

MAY 1981

GENERAL ELECTRIC COMPANY

NASA Lewis Research Center Contract NAS3-21823

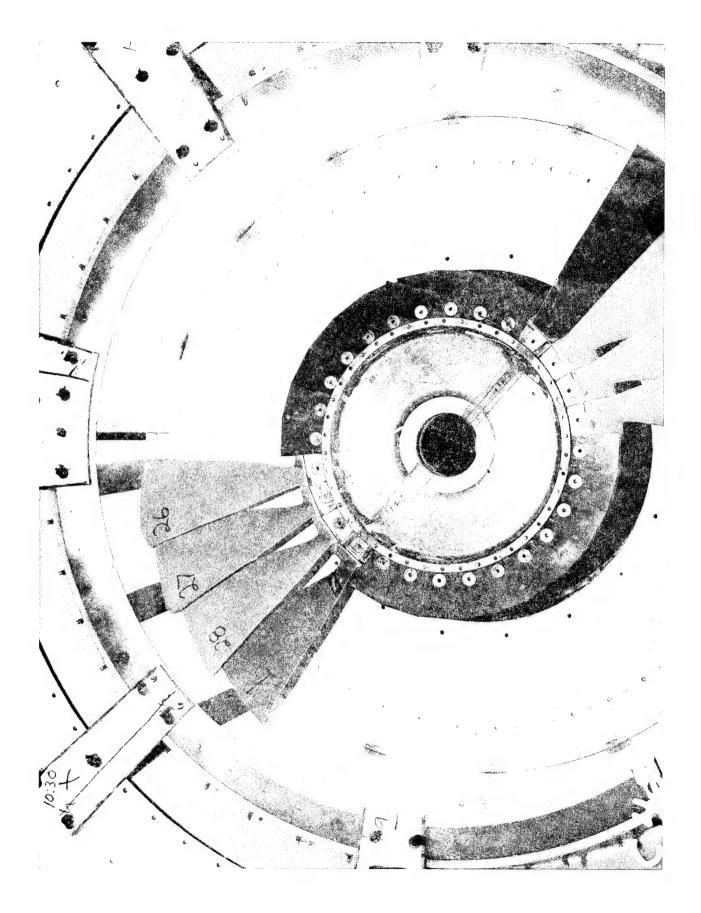
Two TF34 titanium airfoils were released at 4500 rpm into a containment configuration which had 12 plies of dry Kevlar in one 180°-side and eight plies in the other. The containment systems were of typical lightweight construction with a thin steel facing, aluminum honeycomb, Kevlar, and thin aluminum back sheet. It was estimated prior to the test that the side with 12 plies would contain and the side with eight plies would be penetrated. The test setup is shown in Figure 8. In the actual test, the side with eight plies was not penetrated although the aluminum back sheet was ruptured. There was not indication of contact with the witness plate. The rotor and containment systems after test are shown in Figure 9. Typical damage to the flowpath side of the casings is shown in Figure 10. The backside (aluminum outer sheet) of the 12-ply containment system is shown in Figure 11 and that of the eight-ply system in Figure 12. The difference in damage to the Kevlar cloth was not as noticeable, but a progressive teardown of the structures showed that the Kevlar in the side with eight plies was pulled much more toward the center of the containment system (pulled away from the forward and aft ends) indicating that there was significantly greater radial deflection of the Kevlar due to the airfoil impact.

Figure 9. Test 1 - Overall View.

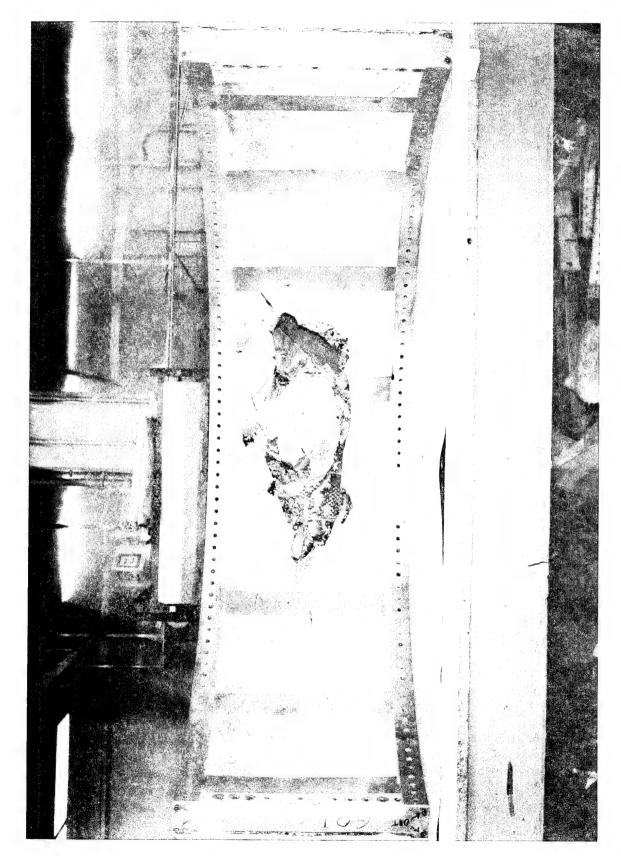
Figure 10. Typical Damage - Flowpath Side - Test 1.

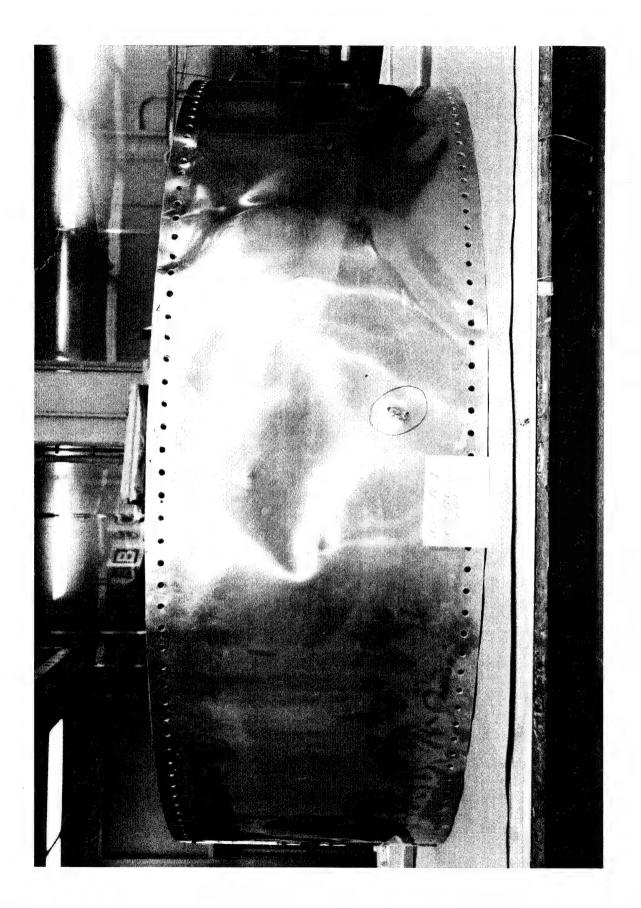
Figure 11. Exterior View - 12-Ply Side - Test 1.

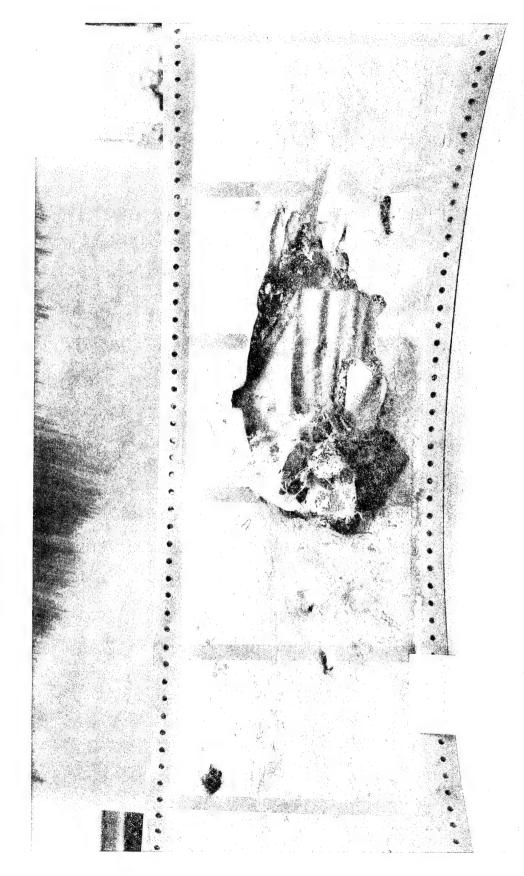
Since Test 1 did not result in penetration of the Kevlar systems, it was decided to run Test 2 with the same containment configuration as Test 1 and increase the rotor speed from 4500 rpm to 5000 rpm. This resulted in a 25% increase in the energy of the released airfoils. The damage of the flow-path side of the 12-ply configuration is shown in Figure 13. Comparing Figure 13 to Figure 10, which shows the damage to an identical containment case when impacted by an airfoil at 4500 rpm (Test 1), it appears that the damage is somewhat greater at the higher release speed and the airfoil is more deeply embedded in the containment. Teardown from the backside, however, did not shown any significant difference in the damage sustained by the Kevlar in Tests 1 and 2. It was obvious that threshold containment was not identified by these tests.

Figure 13. Interior View - 12-Ply Side - Test 2.

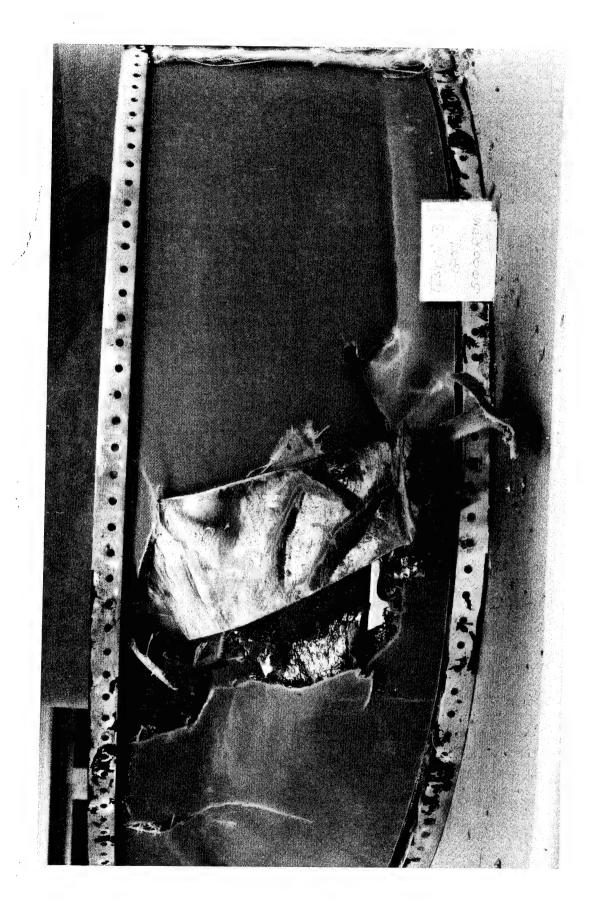
Figure 17. Exterior View - 12-Ply Sidc - Kevlar Removed - Test 3.

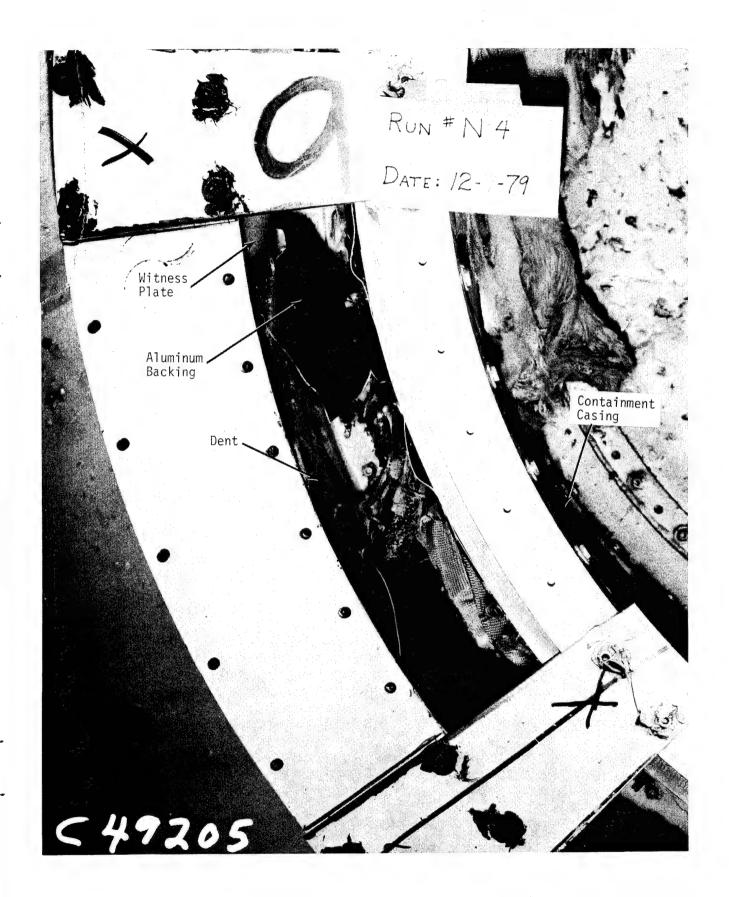
Figure 19. Witness Plate Dent - Test 4.

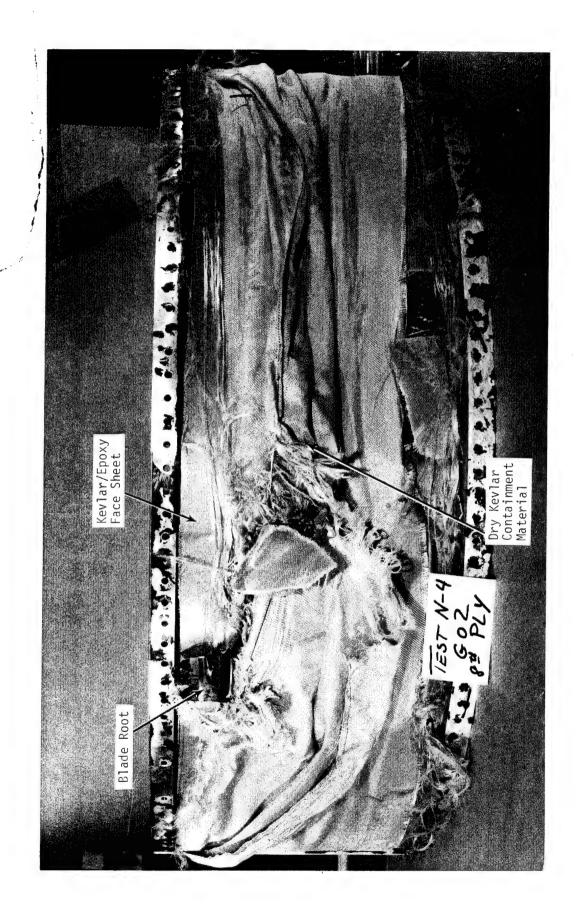
Figure 21. Exterior View - Eight-Ply Side - Test 4.

The superhybrid that impacted the side that had eight plies did not completely penetrate the Kevlar cloth; however, the more aft direction of the blade moved the Kevlar cloth considerably aft as shown in Fiugre 39. This damage can be compared to that caused by an all-titanium blade released under the same conditions into an identical containment system during Test 4 as shown in Figure 21.

released, the cloth was free to move radially outward without adding additional strain to the fibers. If this restraint had remained intact, it is expected that the root section would have penetrated the eight plies of Kevlar in a manner similar to that shown in Figure 21.

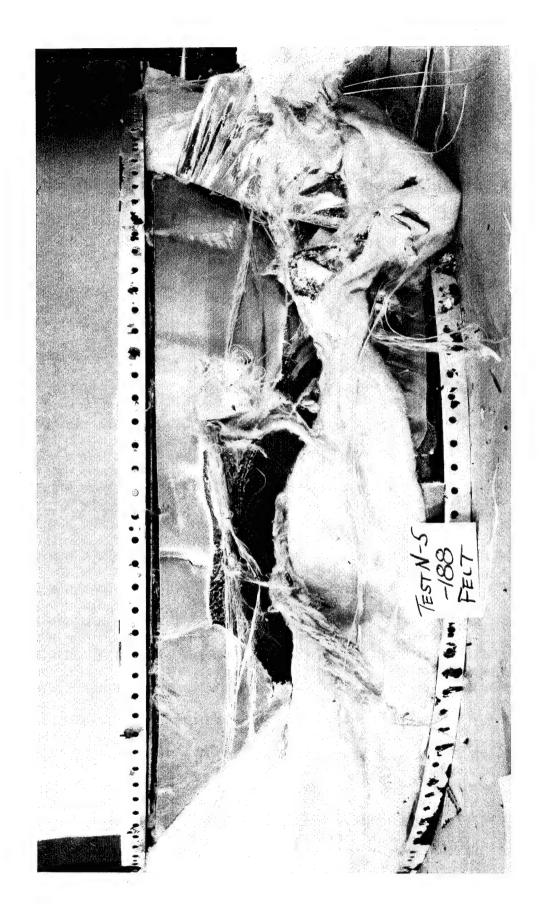
Figure 24. Exterior View - Test 5 - Cloth Removed - Concept B.

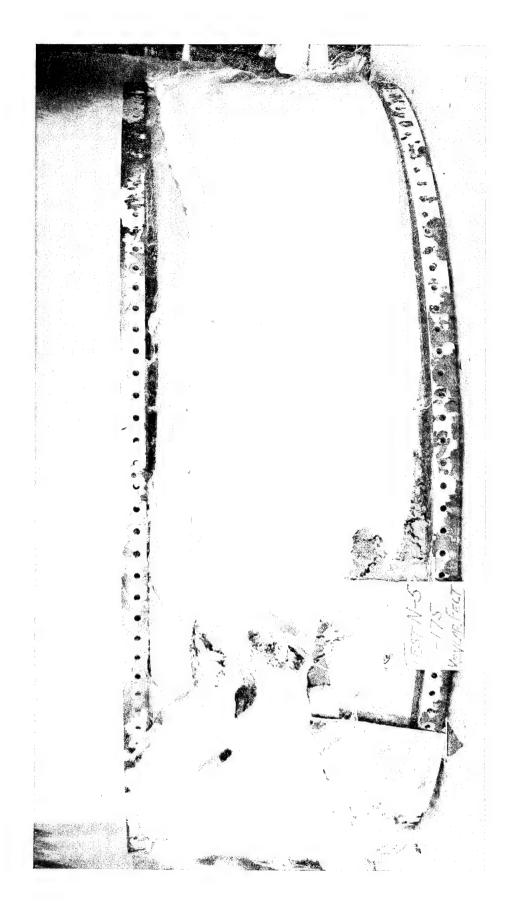
Figure 25. Exterior View - Test 5 - Cloth Removed - Concept A.

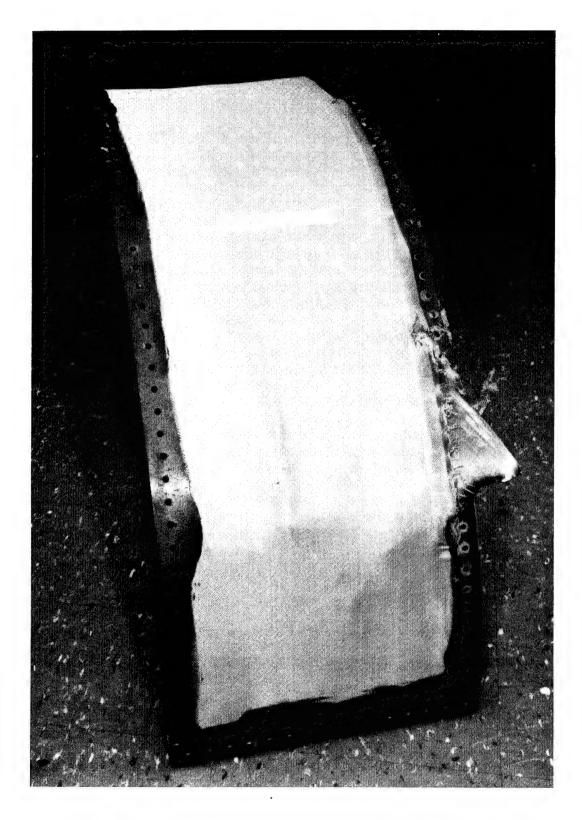
The side with the 328-weave Kevlar was somewhat thicker than the side with 143-weave Kevlar due to the slight per ply thickness difference of the two weaves. The containment characteristics of the 328 weave were much better than those of the 143 weave, even considering the thickness difference. The lack of tranverse fibers allowed the longitudunal fibers to split apart causing a much larger hole than was the case with the more bidirectional 328 weave. This difference can be seen by comparing Figure 28 with Figure 27.

Figure 27. Exterior View - 10 Plies of 328-Weave Kevlar - Test 6.

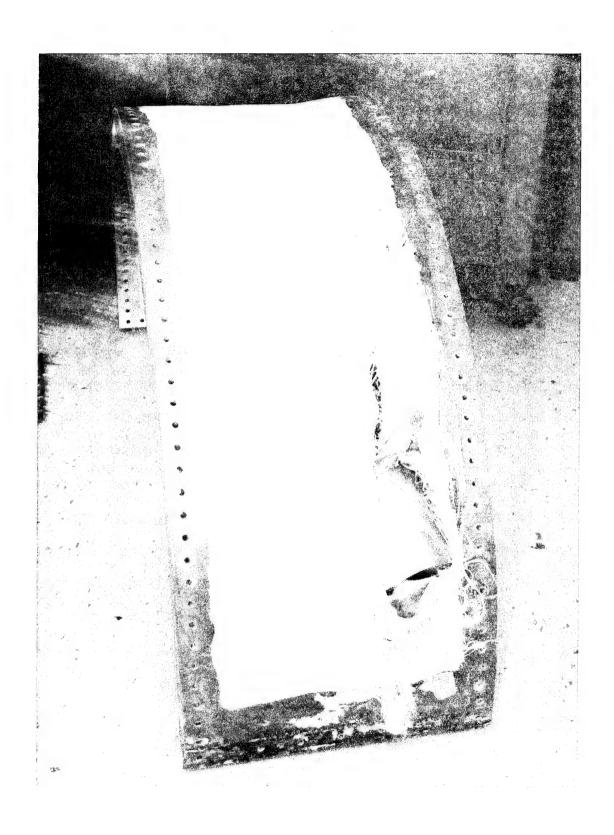
Figure 28. Exterior View - 10 Plies of 143-Weave Kevlar - Test 6.

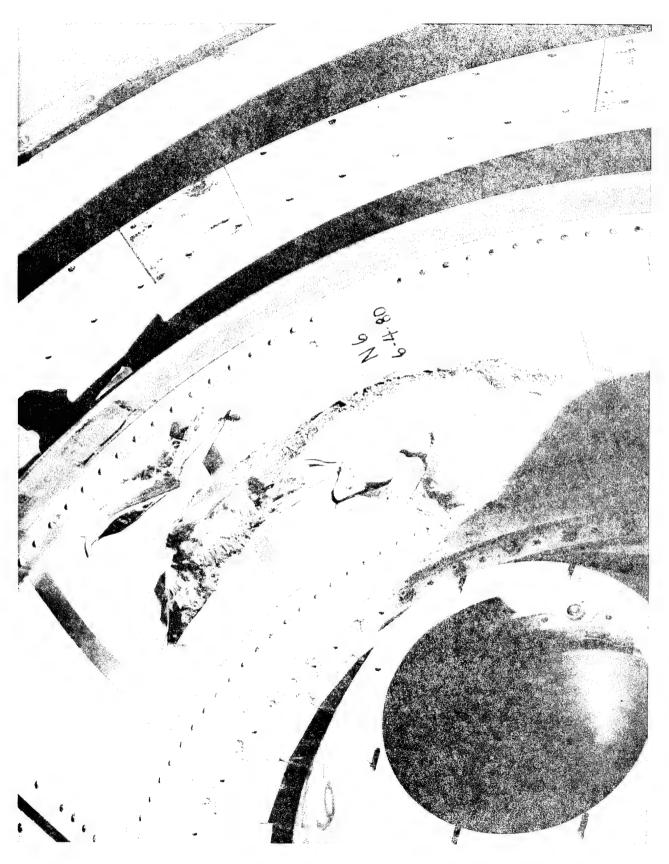
The change from steel to aluminum on the flowpath face sheet did not appear to have any effect on the containment process and the face sheet was not torn up by the impact any more than the steel face sheets used in previous tests run under similar conditions. Since there was no net rotor unbalance, there was no information generated on the rub capability of the aluminum face. The condition of the aluminum face at the impact point is shown in Figure 29 and the condition away from the impact points is shown in Figure 30.

Figure 29. Aluminum Face Sheet - Test 6.

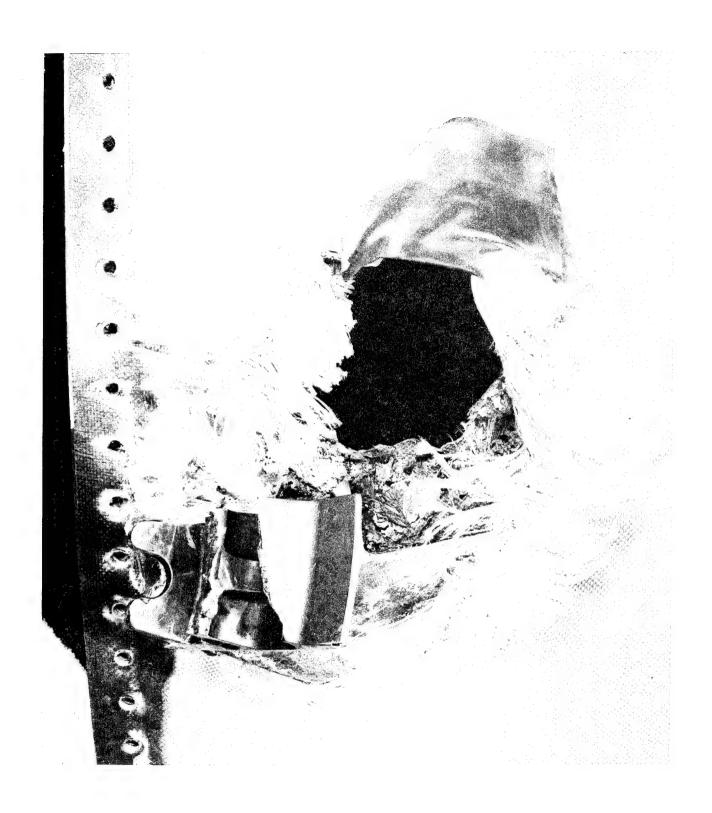
Figure 31. Exterior View - Test 7 - No Felt.

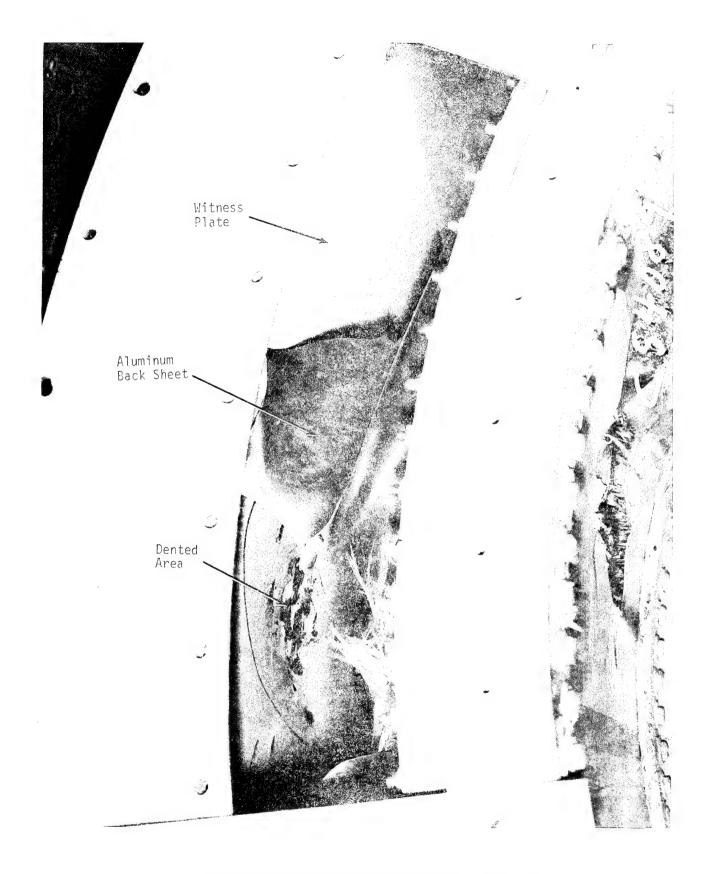
Although the heavier felt did not tear nearly as readily as the lighter felt used on previous tests, the blade roots punctured both the felt and the woven cloth on both specimens. As with the previous test using the 143-weave cloth, there was a splitting tendency due to the small number of transverse (axial) fibers allowing the released blade, encased in the felt except for the root section, to virtually escape from the containment system (Figure 33). The blade would probably have come out except that the root struck the witness plate preventing further radial motion. The damage to the witness plate can be seen in Figure 34. The system with 328 weave was not as severely penetrated but the root section did come completely through the containment in a manner similar to Test 7. Although the heavier felt may have helped some (compare Figure 35 which shows the damage from Test 8 with Figure 32 from Test 7), it was a marginal improvement. This blade too may not have been retained in the containment system if it had not struck the witness shield.

Figure 34. Witness Plate Damage - Test 8.

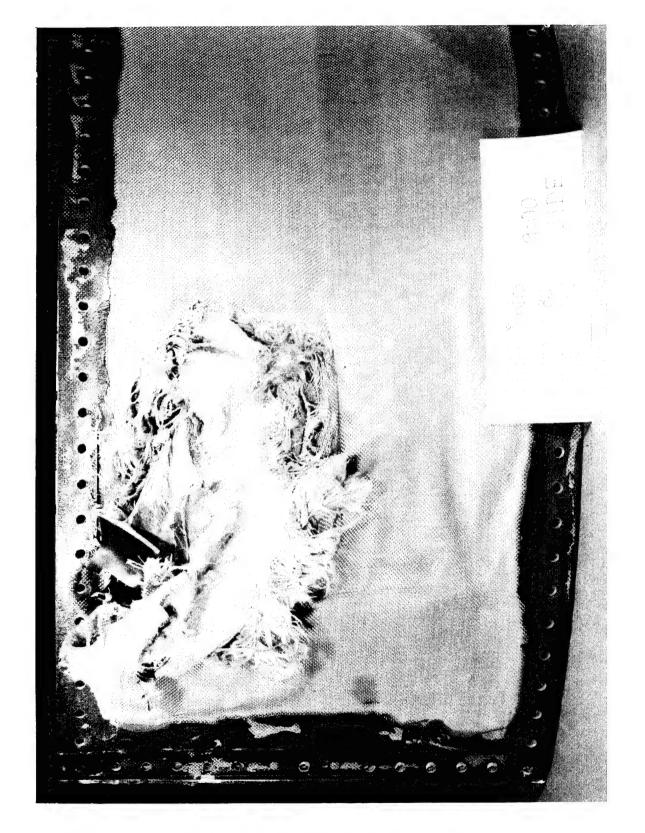
Figure 35. Exterior View - Test 8 - 328-Weave Cloth Plus Felt.

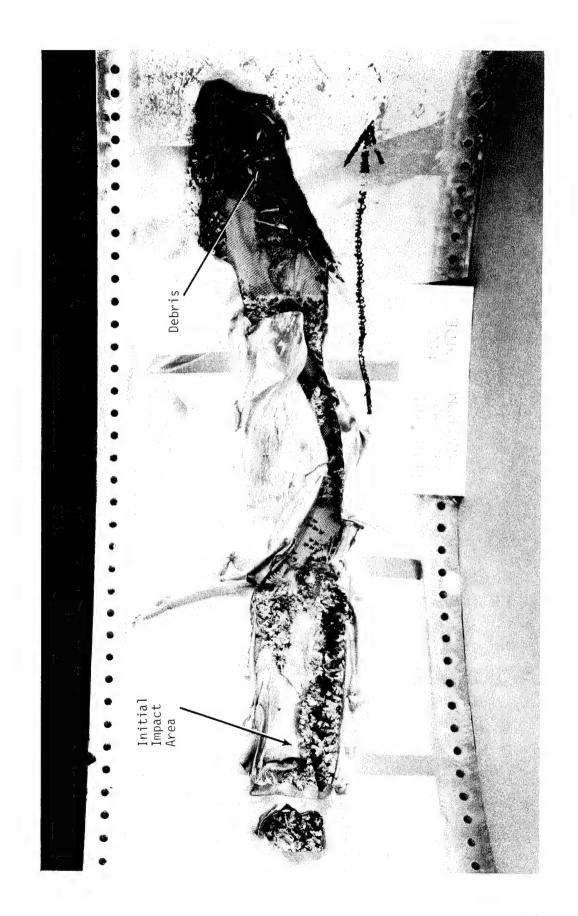
Figure 38. Interior View - Test 9 - Composite Debris.

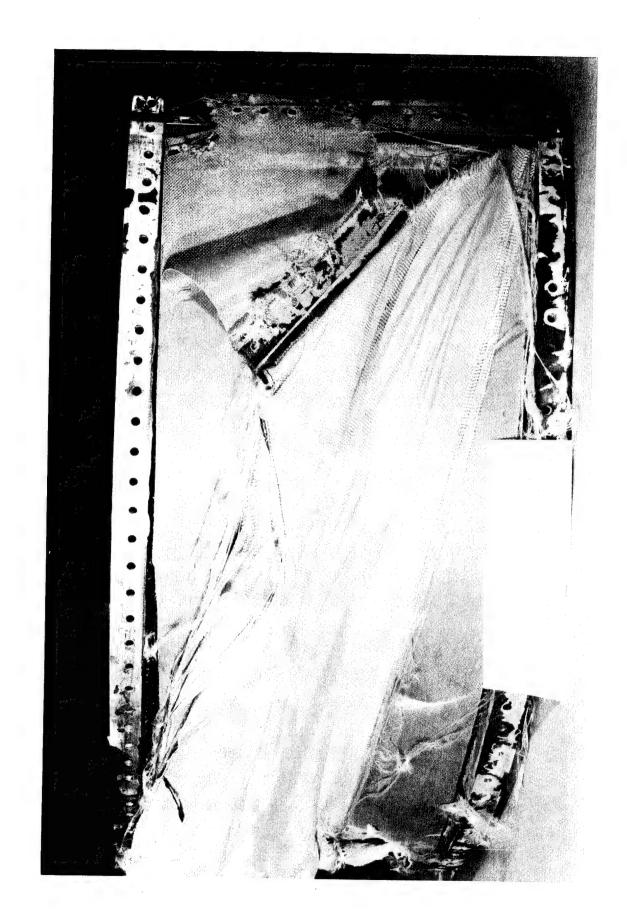
Test 8 was the second test in which the circumferential restraint was broken as shown in Figure 40. This is probably why the root section did not penetrate through the Kevlar cloth; since, with the circumferential restraint

Figure 40. Broken Circumferential Restraint - Test 9.

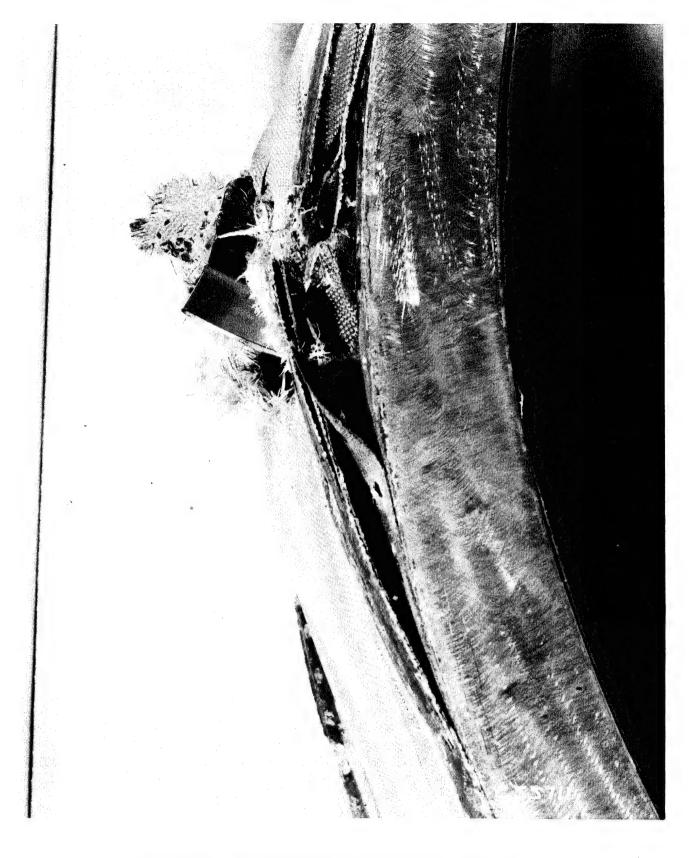
Figure 44. Blade Platform Penetration - Test 11.

Although the blade was well contained, a corner of the platform was protuding through the outer Kevlar plies. If the criteria of no penetration in a commercial application is abdered to, two more plies of Kevlar would be required for this design. Otherwise, the test was very successful and the casing stood up well to the conditions imposed by the high rotor unbalance.

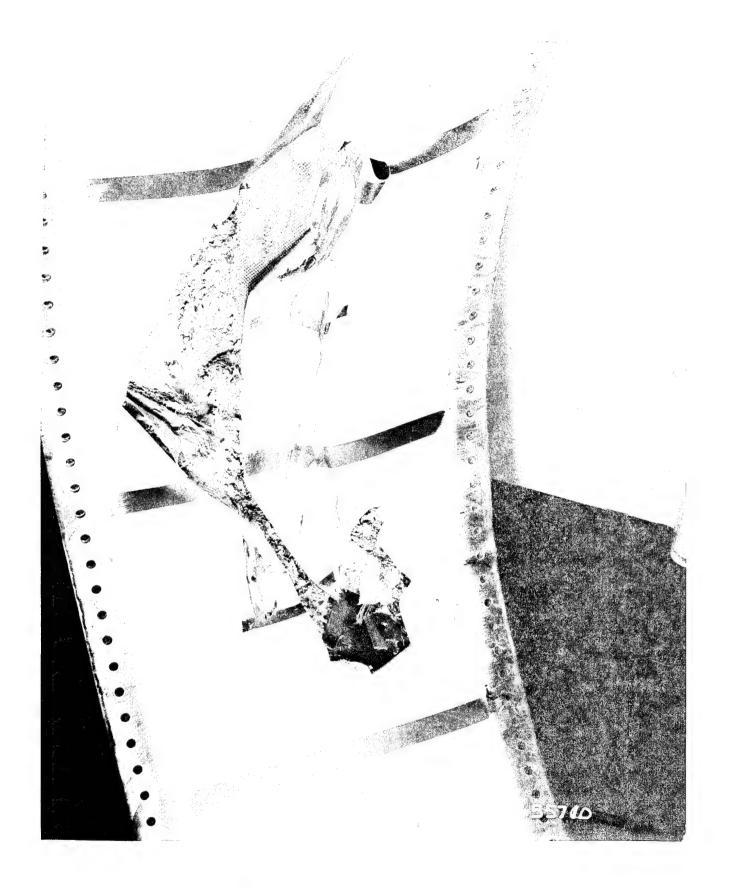
Test 6. The damage in the impact area was typical and is shown in Figure 46. The rotor unbalance due to the blade loss was sufficient for the rotor blade tips to rub on the inner surface of the containment case. A typical rub area can be seen between 6 o'clock and 9 o'clock in Figure 47. A closeup of this area is shown in Figure 48. The face sheet was locally grooved, and there were several small circumferential cracks (Figure 48) but nothing which would significantly degrade the structural integrity of the case. In spite of the impact and the tip rubs, the casing remained round.

Figure 46. Impact Area - Test 11.

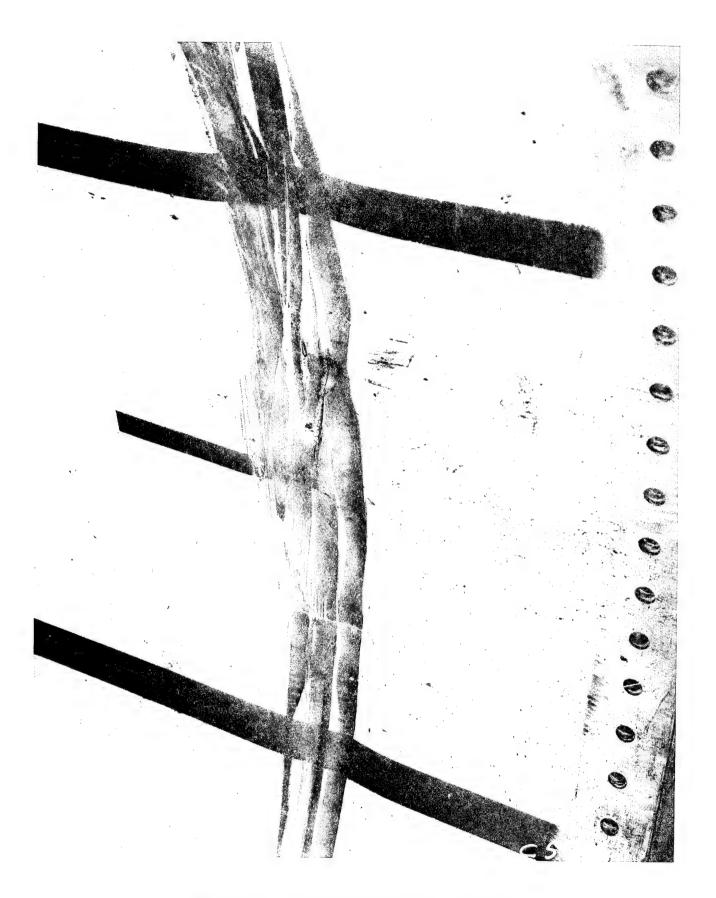
Figure 48. Closeup of Rub Area - Test 11.
